A Detonation Scenario

by Les Waters and Kimble D. McCutcheon

Excerpted from *Torque Meter*, the Quarterly Journal of The Aircraft Engine Historical Society, Inc.
1019 Old Monrovia RD NW STE 201
Huntsville, AL 35806 www.enginehistory.org

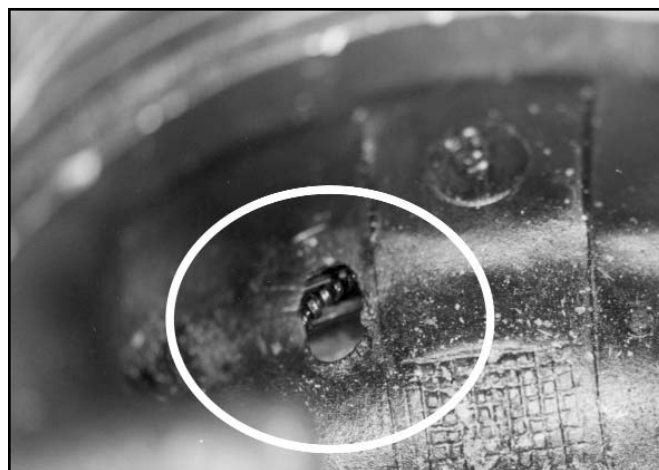
enlarge the hole and allow a terrific amount of blow-by. In addition, the unsupported rings break and their liberated particles create additional collateral damage. The hole in the piston may eventually grow to the point that it relieves enough of the compression pressure for the detonation to cease. The engine continues to run and the pilot still has no clue as to what is going on.

The failure scenario now takes a different path. Excessive blow-by pressurizes the crankcase and the oil spray normally retained in the crankcase spews overboard through the engine's breather. Unless someone is carefully watching the trailing edge of the wing, this too will go unnoticed. The oil supply of the left engine is quickly diminishing. The oil temperature has started to rise and the oil pressure is diminishing as the supply nears exhaustion. Starved of oil, one of the connecting rod bearings (not necessarily No. 3) has heated up. This heating melts the bearing material and the steel backing extrudes from the bearing, forming metal chips that look like corn flakes. The heat has also started to sap the strength from the connecting rod bolts, which begin to stretch. As preload disappears from the rod bolts, they are subjected to a repeated hammering from the inertial forces of the piston changing directions at top dead center. One of the weakened connecting rod bolts fails, releasing the rod cap and loose end of the connecting rod into the crankcase. The loose connecting rod finds its way between the rotating crankshaft and camshaft in just the right way to break the camshaft. The loose rod cap is driven through the crankcase top, leaving a hole the size of a man's palm. It takes less than five seconds for the engine to reduce itself to junk.

A view of the underside of the same piston shows oil hole enlarged by flames (circle). This allows significant blow-by, which pressurizes the crankcase and rapidly depletes the oil supply, resulting in further engine damage. (Les Waters)

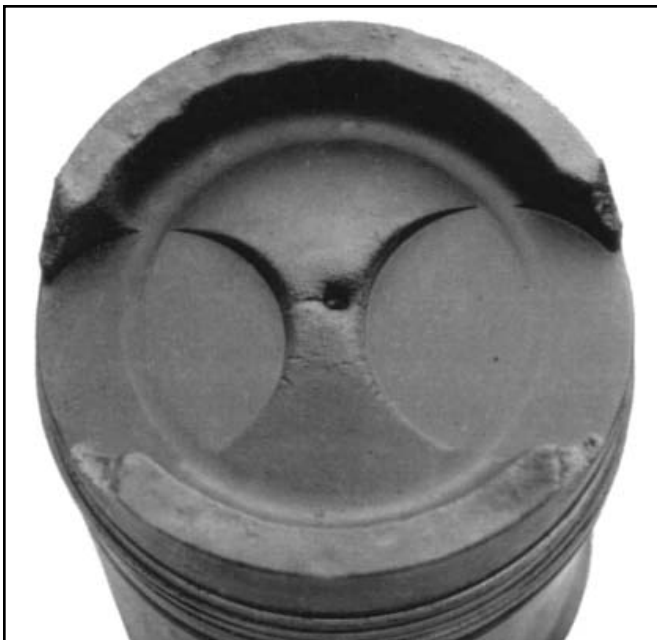
A 10" dual-fuel piston from an engine used to power large electric generators. The piston has been subjected to pre-ignition. Note that, unlike the detonation example, the thermal damage is evenly spread over the piston crown. The piston is made of nodular cast iron, which melts at more than 2,000°F. It must have been subjected to an enormous heat load! The small depression at the center accommodates an eye-bolt used to remove the piston for service. (Les Waters)

A leaking gas inlet valve can remain alight through the exhaust and intake strokes and provide a “torch” to the air/fuel mixture during the compression stroke, resulting in pre-ignition. When this happens on one cylinder, it is usual that high pressures on the compression stroke result in negative work, reducing engine speed. The governor detects speed reduction and compensates by increasing the fuel supply. This runaway condition results in rapid heating of the cylinder heads and pistons. A rate of temperature increase of 20°F per second has been observed at the cylinder head combustion face. It is seldom possible to shut the engine down before permanent damage is done.
